Wind-Related Disaster Risk Reduction in China - From the Viewpoint of Wind Engineering

ABSTRACT: This paper consists of three parts summarizing briefly the wind-related disaster risk reduction activities in China. Although varied unfavorable climate phenomena co-exist in China, typhoon that hits frequently the southeast coast area of China is comparatively a dominant factor responsible for the wind-related damages in China. In this paper, some records of typhoon in China are introduced at first. An example of typhoon damages to human life and properties is then provided, in order to supply a general wind-related damage image in China. Finally some measures to prevent the collapse of non-engineering houses are introduced.

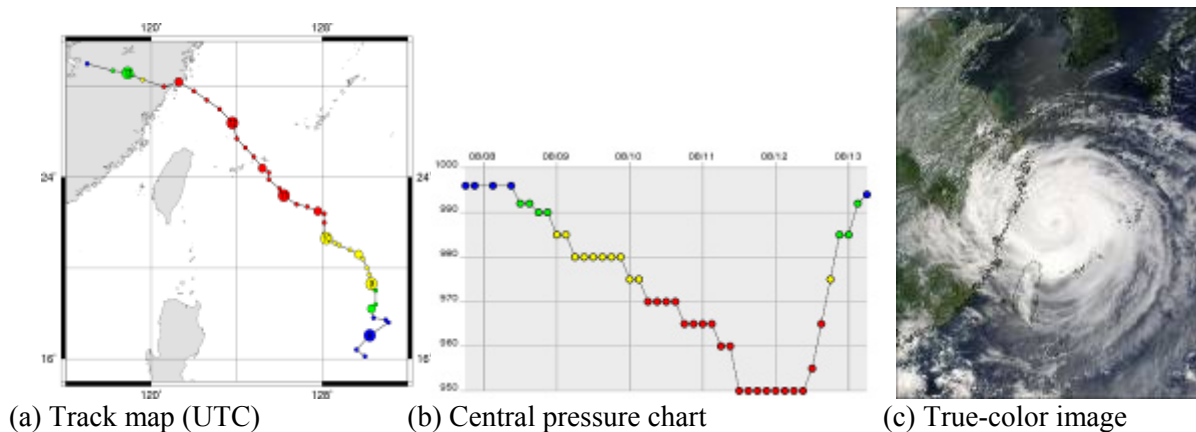
Figure 3 Information of Typhoon Rananim ²⁾

Figures 3a-3b illustrate the route and the center pressure of Typhoon Rananim, which originated on August 8, 2004 at 12:00 UTC over the east Philippine Sea. It developed into a strong, large-scale one to the south of Okinawa Prefecture, Japan on August 10 at 15:00 JST (UTC+9). It passed between the Miyako-jima island and Tanama-jima island of Okinawa on the night of August 11 with a center pressure of 950hPa and a maximum velocity of 40m/s. The recorded maximum instantaneous velocity was 42.2m/s at Ishigaki at 16:21 JST and 48.8m/s at Miyagoko-jima at 20:10 JST. Three persons were injured when Typhoon Rananim passed Okinawa. It hit southeast China on August 12 at around 20:00 with a sustained center pressure of 950Pa. It moved through Zhejiang province for 15 hours and finally died on

August 13 at 6:00 UTC. Figure 3c shows an image of Typhoon Rananim, captured by NASA's Terra satellite on August 12 at 2:40 UTC.

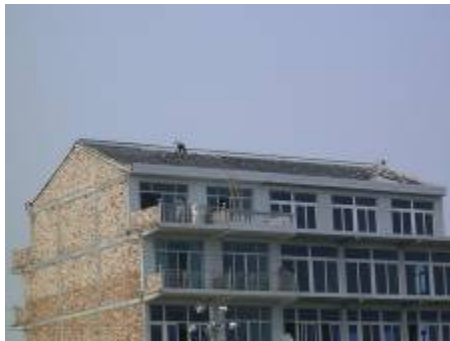
Fig.5 Structure of dwelling

The collapsed houses that caused injuries were mostly farmers' dwellings in the countryside. They were commonly 2-3 storey structures with concrete frames, brick walls and tile roofs. Figure 5 shows an example of a somewhat larger dwelling. The roof and side wall supported each other. There were two types of tile system for dwellings. In the first, the wooden plate or small bricks were laid out over the rafters, and then the tiles were laid out (Figure 6). In the other, the tiles were laid directly onto the rafters (Figure 7). The latter type was rarely used recently in this area. Furthermore, there were generally two kinds of tile. One was the Chinese traditional type, as shown in Figure 7, and the other had a similar shape to the Japanese tile, as shown in Figure 6. When Typhoon Rananim passed, a great amount of damage occurred on roof tilts. On the S87 road from Wenglin city to Shitong town, which is about 10km long, over 50% of dwellings suffered severe to moderate damage to their roofs, irrespective of the dwellings' age. Collapses of this kind of houses killed 109 persons, and was the primary cause of death and injury. The collapse mechanism seemed that, the house roof was first broken by the strong wind, which removed the support for the brick or stone walls, resulting in their collapse (Figure 8). It was also noticed that the collapsed houses were on open areas some distance from the villages, where the wind speed was greater. In addition, traditional Shitong houses were built of stone. Figure 9 shows a collapsed stone house that had no actual structural frame.

Damage to roofs of low-rise buildings, e.g., dwellings and factory buildings, was too severe in this typhoon. It caused direct damage to life and property inside buildings. Utilization of a fixed link between the side wall and ceiling, and utilization of high strength materials for ceilings may be considered to enhance the wind resistance of roof structures.

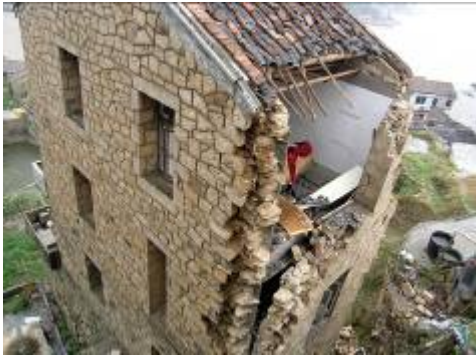
Fig.9 Collapsed stone house

It was noticed that stones or bricks were put on the roofs of some houses to protect the ceilings from strong wind (see Figures 9 and 10). This misguided action was ineffective in preventing ceilings from blowing off, but possibly increased the amount of windborne flying debris. The method of laying nets on house roofs, which was used in Kyushu, Japan, was a more effective method²⁾. In the countryside, farmers usually build their houses in their traditional manner rather than following relevant national codes such wind resistant design standards. This is one of the reasons for the poor wind resistant performance of their houses. In

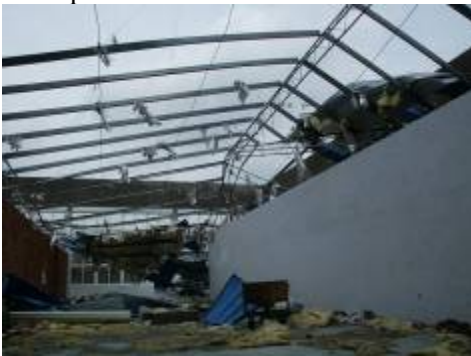
Fig.11 Damage to factory building roof

Most work sheds and factory buildings in the countryside are one-story structures with steel sheet or slate roofs. These buildings were also seriously damaged during the typhoon. Figure 11 shows the roof of a factory building that flew away. Figure 12 shows an example of a roof that fell down during the typhoon. Figure 13 shows the steel frame of a factory building whose roof and wall were totally destroyed.

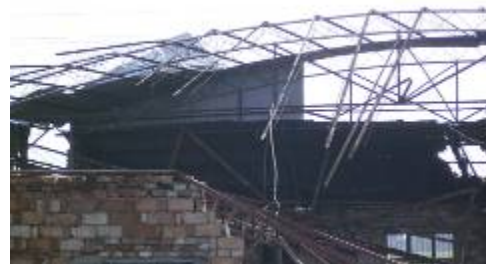
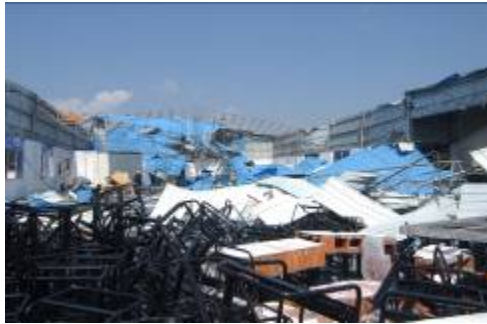
Damage to the work sheds shown in Figures 14 and 15 was much more severe: They completely collapsed.

Fig.14 Damage to work shed

Fig.15 Damage to work shed

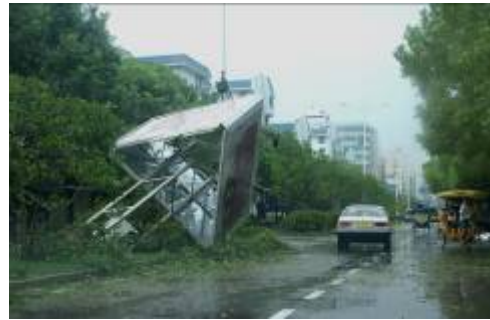
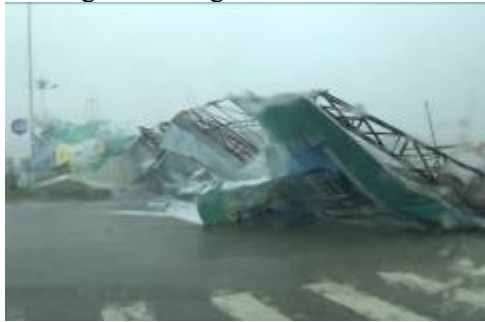
Fig.16 Collapse of advertising board

Fig.17 Collapse of advertising board

Wind damage in the city included collapse of advertising boards (Figure 16 and 17), collapse of trees (Figure 18), flooding in downtown areas (Figure 19), and collapse of electricity poles (Figure 20). Flying of windborne debris hit buildings and cars, causing damage to glass.

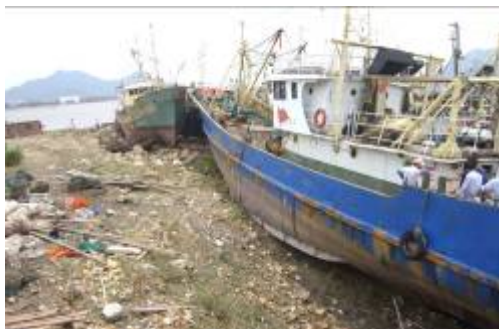
Fig.20 Damage to fishing vessels

Fig.20 shows a fishing vessel that was pushed aground by the strong wind and large tide. Fig.21 shows an agricultural plastic house that was destroyed.
